EXPLOSION IN THE PITCH SYSTEM BATTERY BOX

QSE Alert

Non-Conformity Code associated: NC2015000849

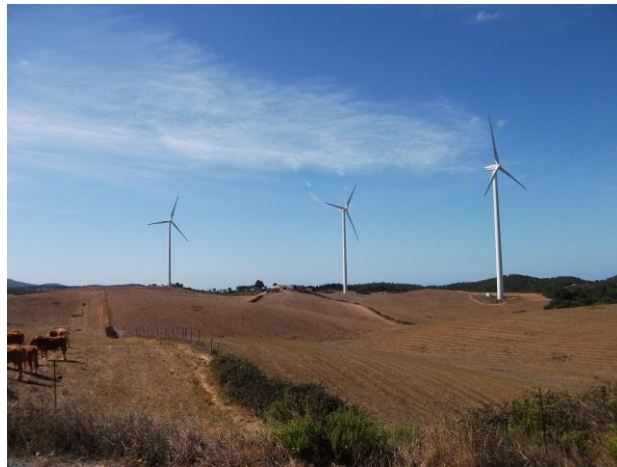
Location of the explosion: battery box

The turbine had been shut down for approximately two days due to pitch system failure. During the first day of shutdown, various jobs (battery and motor replacement, wiring modification, etc) were carried out on the pitch system, but the control system problem persisted. Work continued on the machine during the second day, but again without any success. The batteries were repeatedly charged and discharged during all these attempts to resolve the fault.

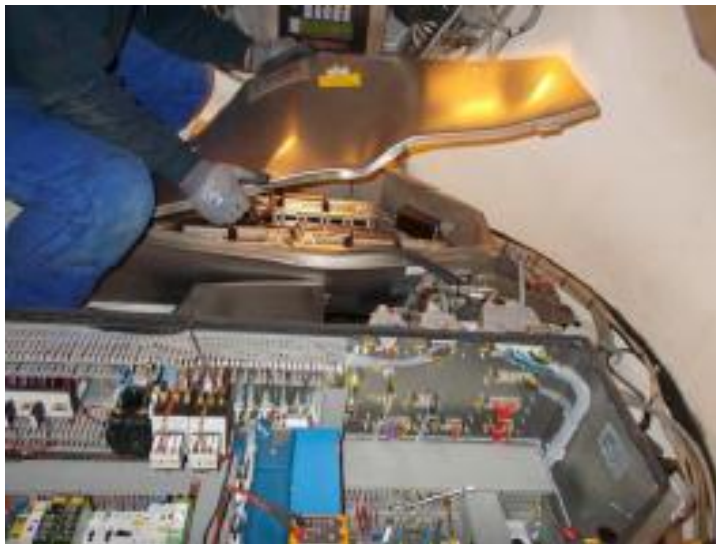
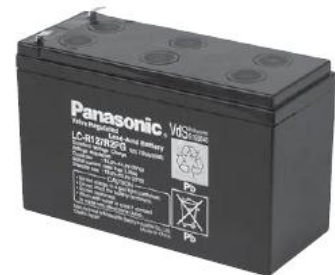
At a given moment there was a large explosion in the pitch battery box. When this occurred, one of the engineers was sitting on the box operating one of the pitch system control panels for one of the blades (the box had its cover fitted, but was not locked with its key). This engineer was violently sent flying by the explosion, which caused the previously described fractures. His companion only suffered minor injuries.

Everything points to the repeated charging cycles that the batteries underwent causing damage to some of them producing an unusual release of hydrogen gas with an extremely low inflammability limit. The hydrogen mixed with the oxygen in the air, together with a still unknown ignition source, caused the explosion. This ignition source may have contact of a tool with some metal part of the hub.

- The electric pitch hub batteries may release hydrogen, a highly inflammable gas. The following general recommendations must be taken into account to prevent it:

- In case of a problem, the entire block must be replaced; under no circumstances should batteries be changed individually.
 - Do not subject the batteries to repeated charge and discharge cycles because this could damage them.

- Check the battery technical specifications and use them according to the manufacturer's instructions (do not force or handle them internally and respect their usage limits, etc).

- The following should be specifically performed:
 - Assess each electrical pitch turbine for the actual risk of hydrogen being produced in the hub batteries and define a specific work protocol.

- Ensure that the battery boxes are not sealed. If their design includes membranes to allow battery cabinet aeration, verify their correct operation.
 - Prepare a list of alarms per turbine that could indicate possible release of hydrogen. If hydrogen release is suspected in the hub, disconnect the auxiliary services to the pitch system and establish a waiting time to allow for aeration before entering.

- Do not carry out hot-working processes inside the hub without first having discarded the possibility of hydrogen being present using adequate measuring equipment.
