An electric arc occurred when introducing a metal guide into the wind turbine transformer enclosure.

Associated non-conformity code: NC2017003077

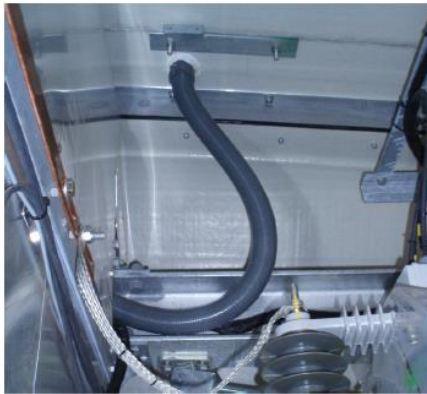
Close-up of the flexible tube inside the transformer enclosure through which the environmental sensor wiring passes.

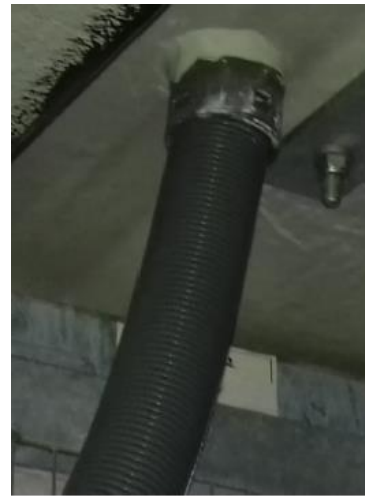
Close-up of the upper flexible tube fastening inside the transformer enclosure.

Because of all this, it is suggested that the flexible tube was freed from its upper fastening due to being pushed and forced by the metal guide, with the latter becoming hooked inside the tube and, instead of exiting outside the nacelle as expected, it was introduced inside the transformer enclosure, increasingly further, until at a given moment, when it came into contact with one of the transformer phases and the frame (earth). This moment was when the short-circuit was produced, coinciding with when the technician was checking where the guide was inside the nacelle by peering through the transformer enclosure grille.

- Design a more reliable flexible corrugated tube upper (gondola ceiling) fastening system. It is currently secured by tabs and it is proposed that it be fastened by a pass-through screw.

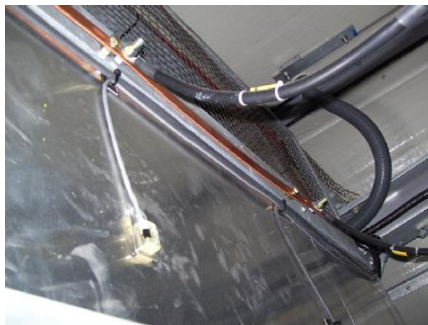
Close-up of the transformer enclosure upper grille and of the flexible tube exit towards the nacelle,

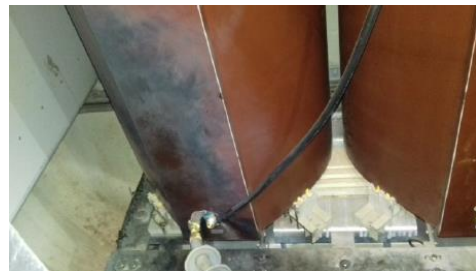
- the metal frame of the lower part of one of the transformer phases showed signs of heat damage.
- there were pieces of metal rod inside the enclosure, which came from the metal guide that had been inserted into the tube in order to pass the sonic anemometer cable.
- the flexible plastic tube was hanging from the transformer enclosure wall (not from the cowling ceiling) and it had several holes that were probably caused by the high temperature of the metal guide coming into contact with the tube.

Close-up of inside the transformer where the short-circuit probably occurred.

- Tools must never, under any circumstances whatsoever, be introduced into an energised HV enclosure, except when absolutely certain that the hazard distances with "live" parts are not going to be invaded. This can only be guaranteed if there is a rigid stable barrier to prevent such contact.
