ELECTRIC SHOCK WHILE WORKING ON AN ELECTRIC TRANSMISSION LINE

QSE Alert

Associated Non Compliance Code: EV000000433

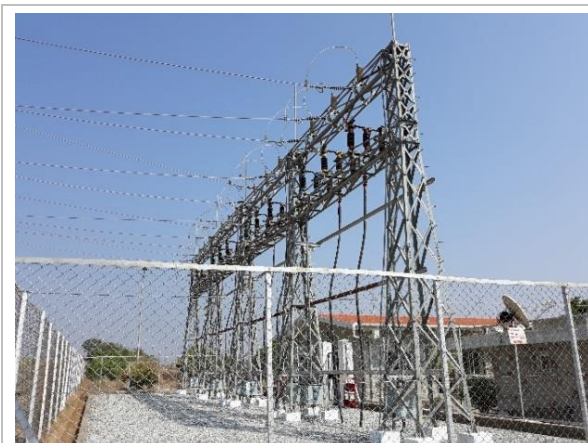
Detailed view of the gantry structure of the substation at which four circuits arrive from the wind farm (two double circuit lines).

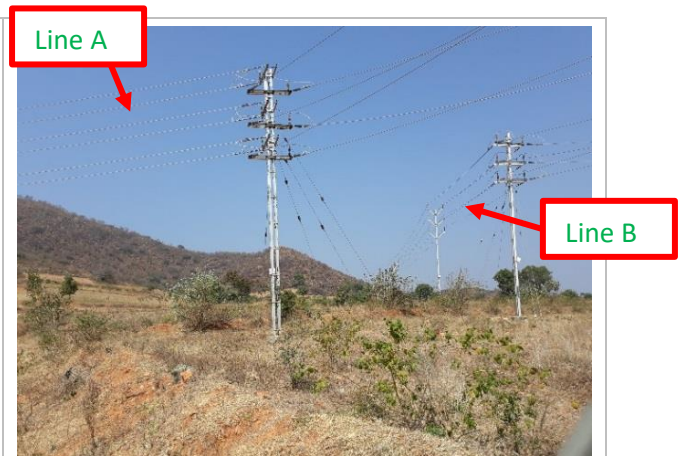
Detailed view of the two double circuit 33 KV lines (A and B) arriving at the substation from the wind farm. The lines are not parallel.

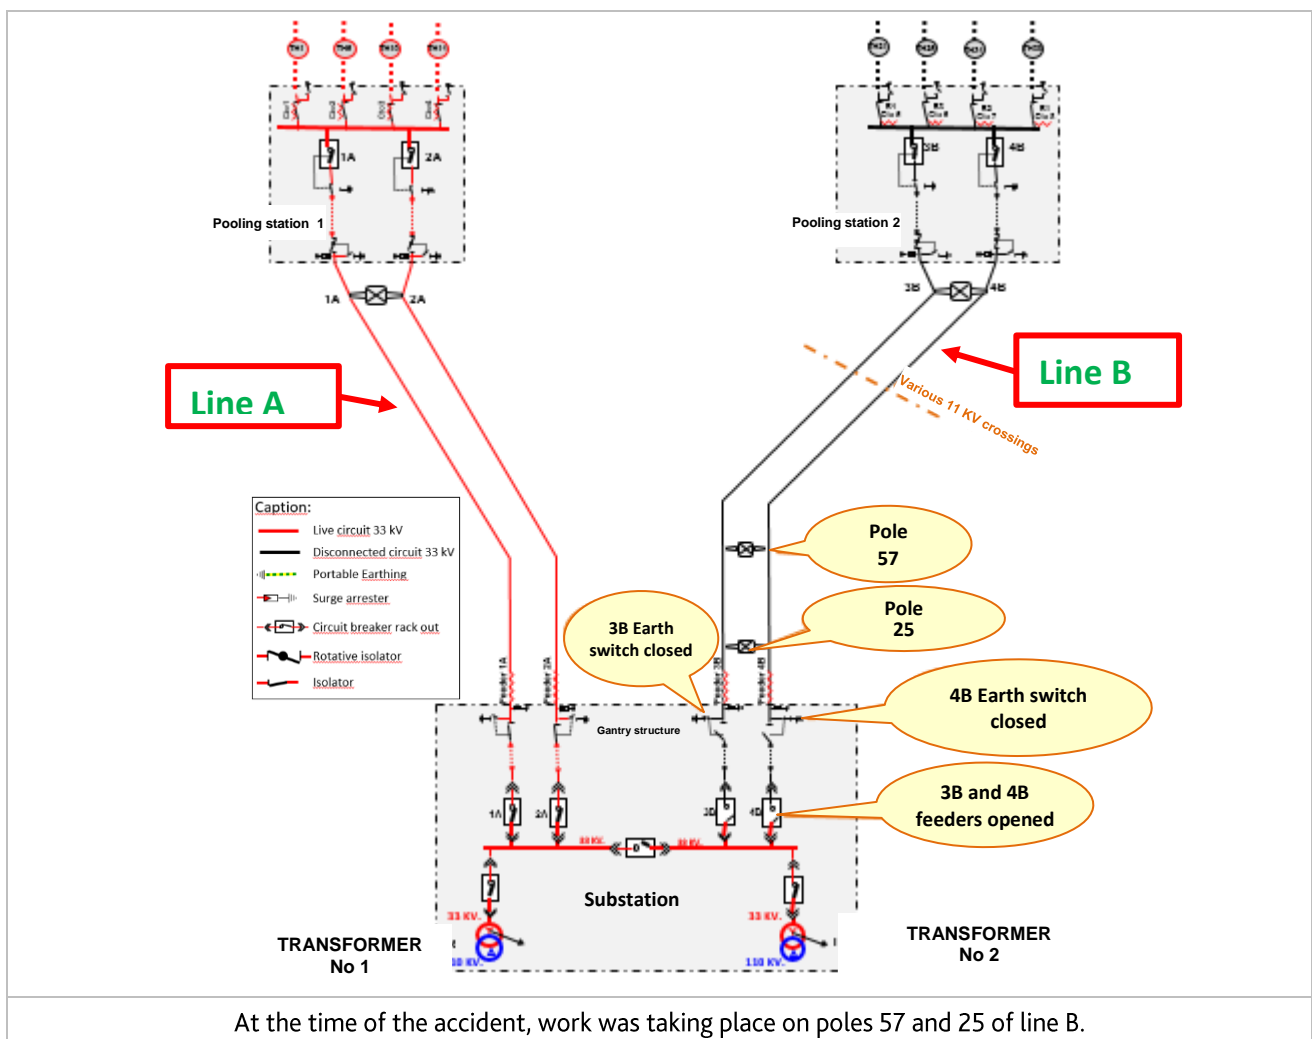
- Isolation point at the substation: circuit breaker + isolator 3B and 4B opened and tagged out.
- Isolation point in the wind farm: circuit breaker + isolator 3B and 4B closed, therefore, isolation **not implemented** on the wind farm side.
- Earthing of the line on the substation side: 3B and 4B closed and tagged out.
- Earthing of the line on the wind farm side: 3B and 4B open, therefore earthing not implemented on the wind farm side.

Early in the morning and after putting line B on "outage", work started. The electric situation of the line was as indicated below:

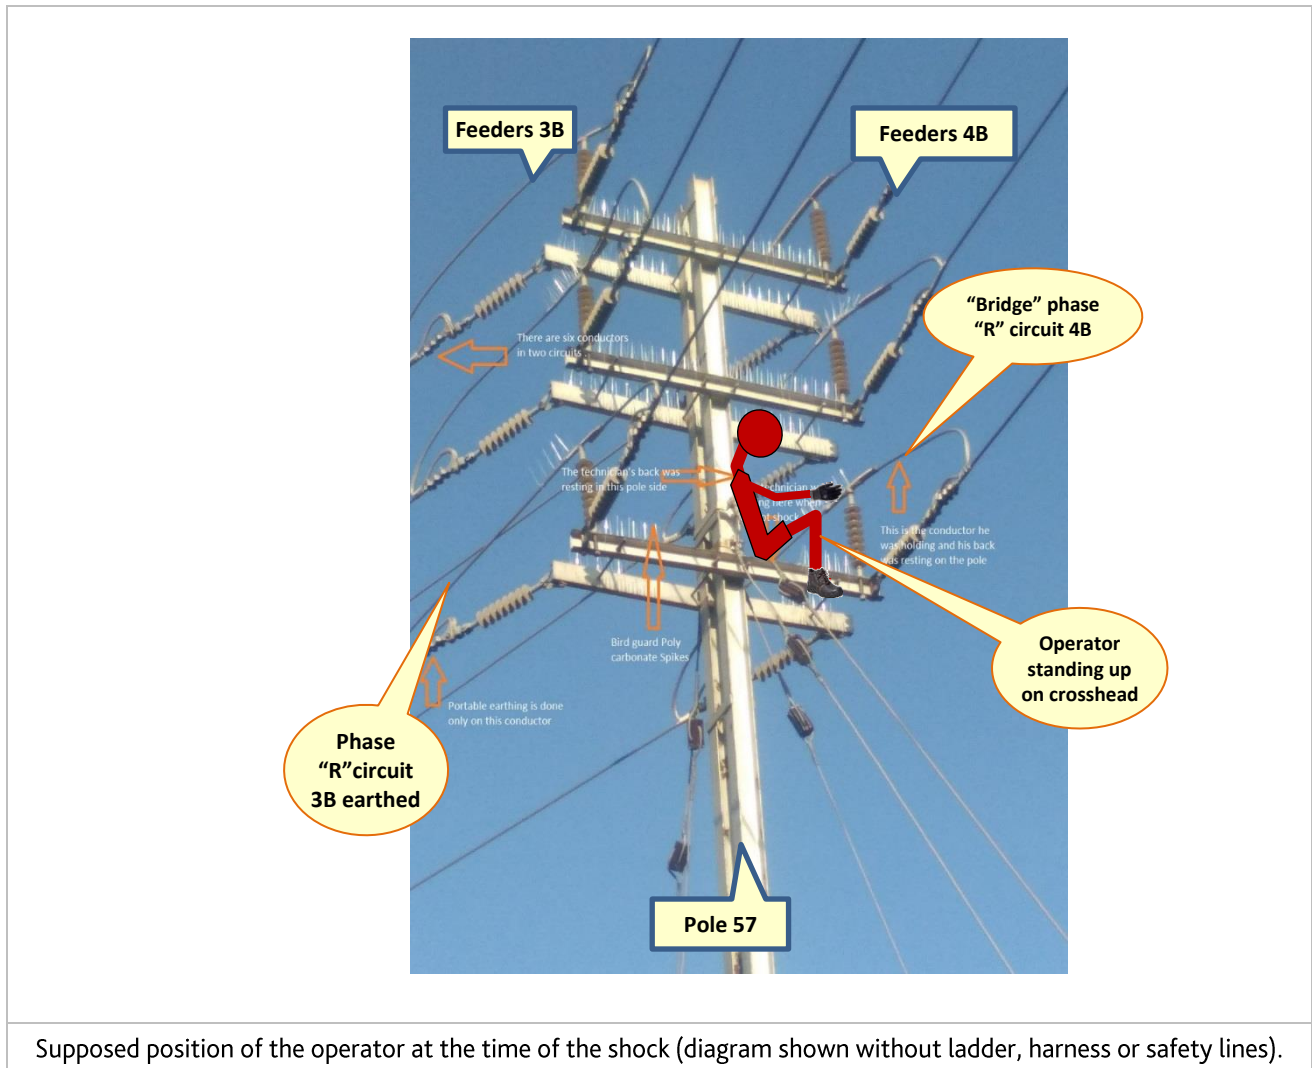
At a particular moment, an operator who was at pole 57 received an electric shock, which seemingly only caused a minor shock and no more serious injuries. He immediately descended from the pole on his own.

Supposed position of the operator at the time of the shock (diagram shown without ladder, harness or safety lines).

It should be noted that the work zone on support pole 57 of the line was not correctly protected with portable earthing, only one portable earth lead had been mounted on one of the phases (phase R, circuit 3B, wind farm side). Moreover, this portable earth cable had a cross-section far lower than that was required for the given short circuit current of the 33kV line conductor.

Whether the origin of the discharge was a return current as in this case or it was caused by induction from another line, **the accident would have been prevented if the working area at pole 57 had been correctly protected with portable earthing of adequate cross-section in all the phases.** Therefore, the lessons learned following this accident are mainly aimed at remembering the **vital importance** of the **correct creation of the protected area and working area** whenever work on high voltage electric lines is to take place:

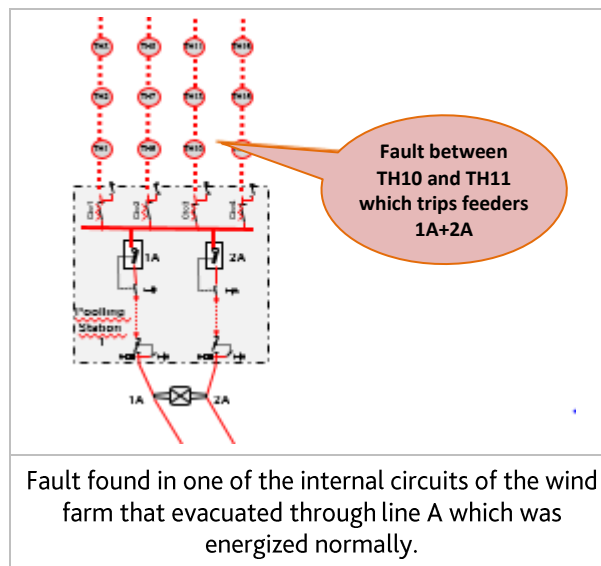
Shortly before the accident there was an unexpected trip on line A. The wind farm maintenance company (different to the maintenance company mounting the bird spikes guards on line B), following different tests selectively energizing the internal circuits of the wind farm to locate the origin of the fault in the wind farm itself (underground cable in circuit 3).

After analyzing the information saved in the protection relays of the substation, it was found that at the same time of the accident occurred, a trip had been recorded due to "function 51 or timed trip" with a current of 998.2 A.

Homopolar return current caused by operations carried out in the wind farm to locate the internal circuit which was causing the fault. The return current reaches the transformer neutral in the substation through the earth mounted on phase R of circuit 3B mounted on support at pole 57.
