ELECTRIC SHOCK WHILE WORKING ON AN ELECTRIC TRANSMISSION LINE

QSE Alert

Associated Non Compliance Code: EV000000433

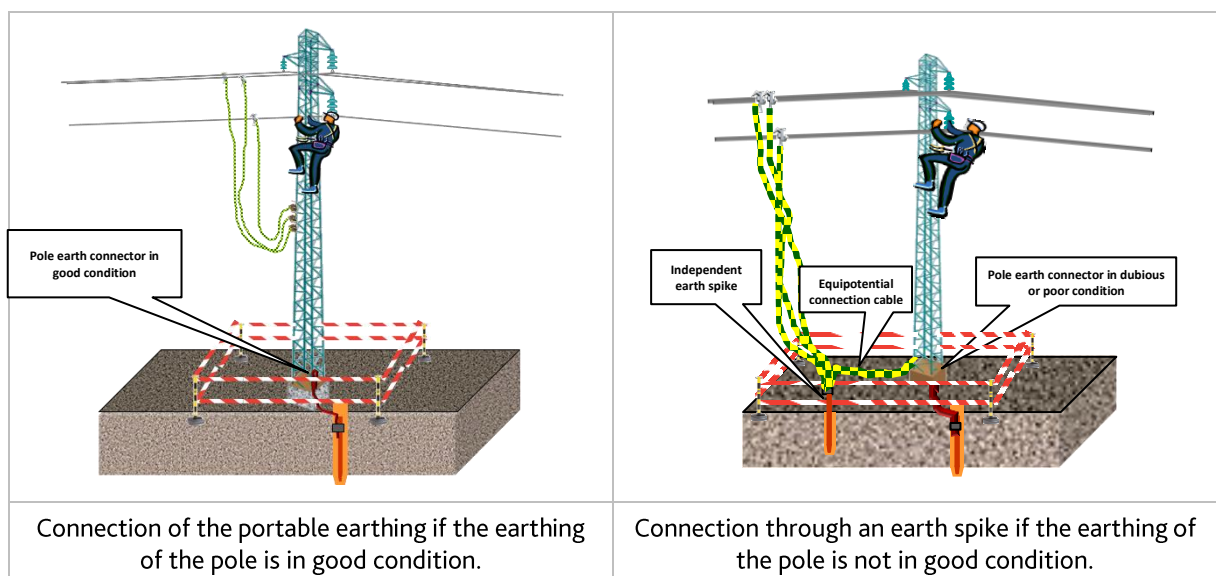
- Visible portable earthing on all the phases at a point close to the pole on which the operator is working.
 - The portable earthing must provide equipotential, either connected directly to the pole or through earth spikes connected electrically to the pole.

- The portable earthing used must have an adequate cross-section to withstand the short circuit current. This figure is not standard or fixed according to the rated voltage of the line but depends on the short circuit current of each facility.
